NASA Technical Paper 1699

AUGUST 1980

# Crash Tests of Four Identical High-Wing Single-Engine Airplanes

Victor L. Vaughan, Jr., and Robert J. Hayduk  
*Langley Research Center*  
*Hampton, Virginia*

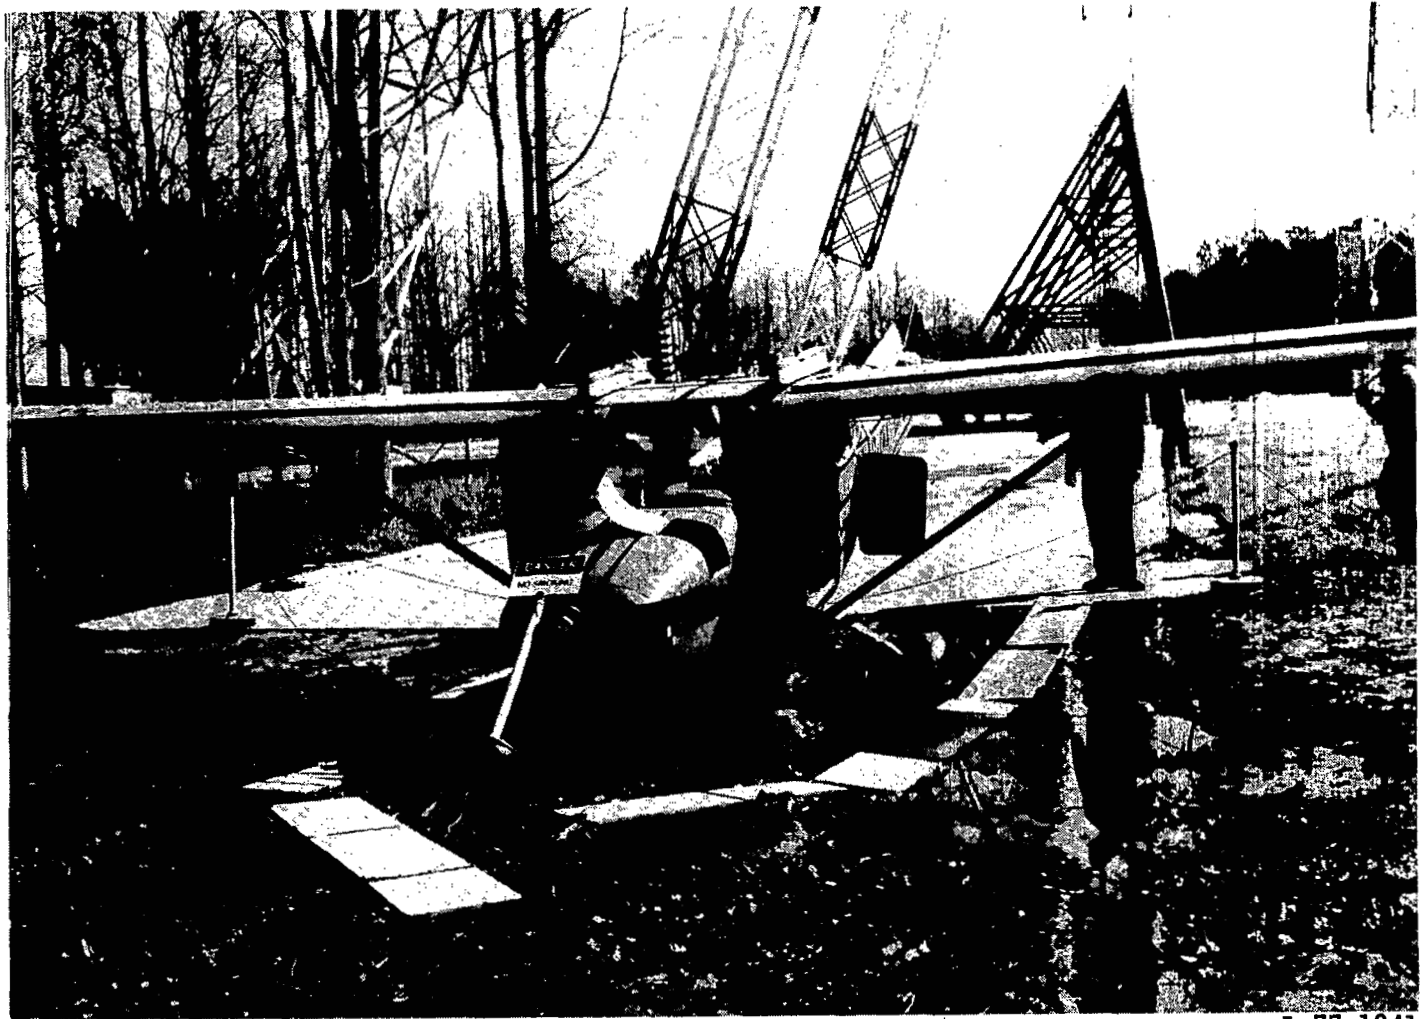
L-77-1841

Figure 15(a) shows the airplane resting on the main landing gear, the collapsed nose gear, and the forward fuselage structure. There appeared to be little structural damage overall, and the occupants appeared to be sitting in a normal upright position in undamaged seats. A close-up view of the nose landing gear and the fuselage attachments are presented in figure 15(b). The composite wheel fairing was broken during impact. The lower attachment of the landing-gear strut was broken away from the fire wall and fuselage structure; the top attachment was torn away from the fire wall at the lower edge and rotated back into the fire wall at the top edge. During the impact, the wheel fairing rotated upward and damaged the engine air scoop.

(a) View of front of airplane.

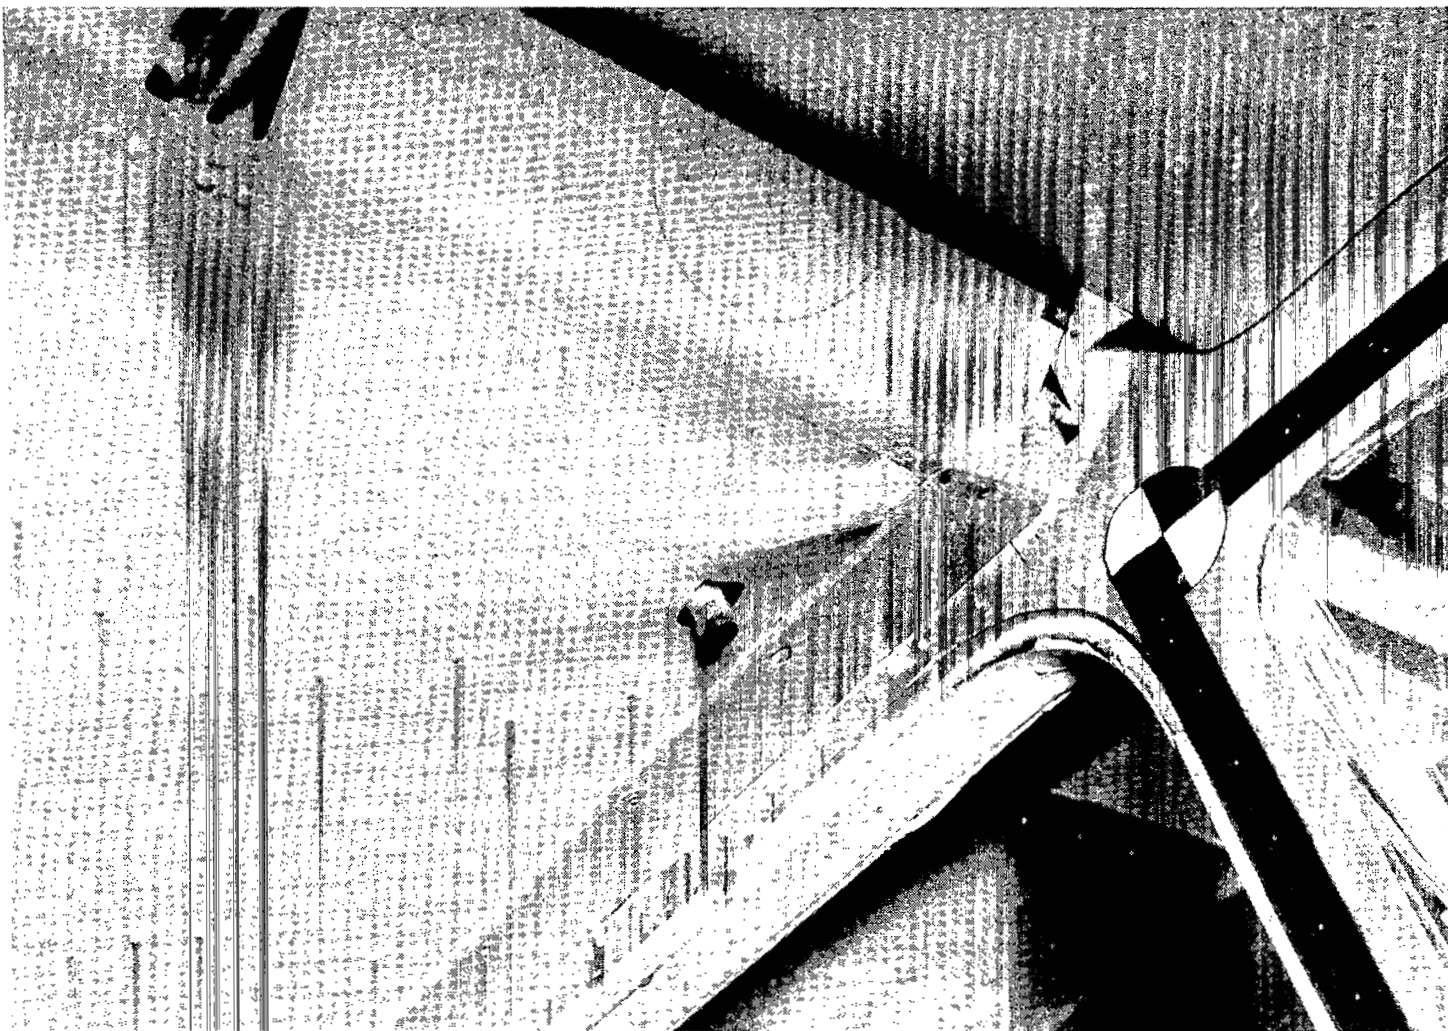
L-77-1878

(d) View of trailing edge of wing at fuselage junction.

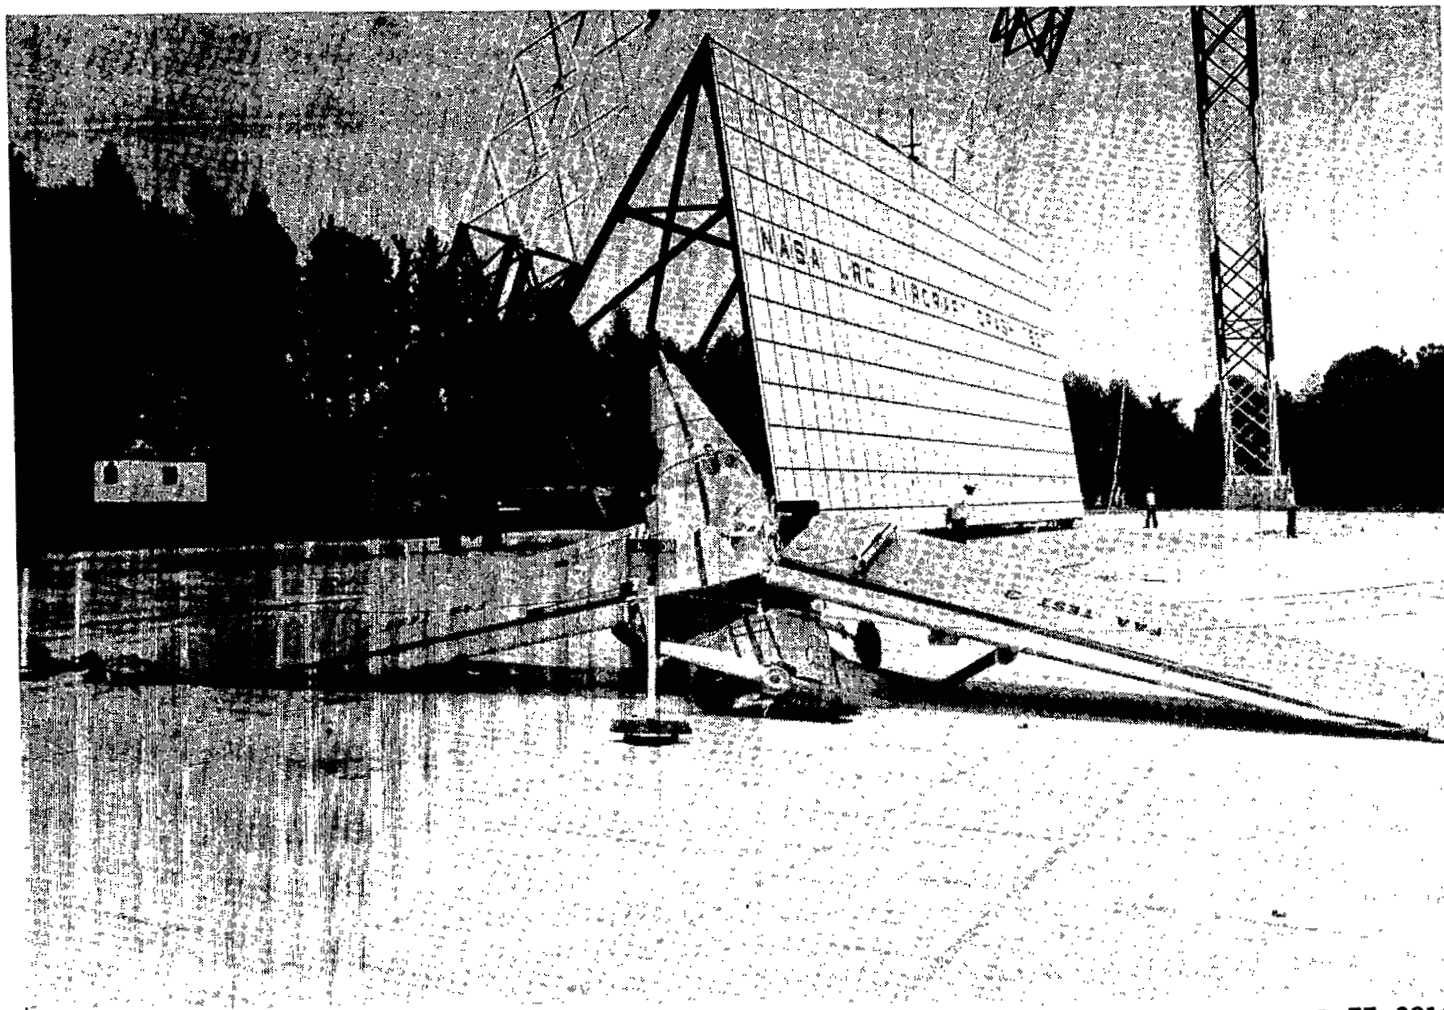
Figure 18(a) shows the final resting position of the airplane and the overall structural damage viewed from the front. The slight S-shape of the fuselage (i.e., the nose to port of center line and the tail to starboard of center line) is apparent and resulted from the off-axis impact. The starboard wing is severely damaged near the tip where first wing contact occurred. The off-axis impact on the starboard wing and nose caused the port wing to break away from the fuselage. The impact was severe enough to buckle the starboard wing strut, which is a very stiff structural element. Figure 18(b) again demonstrates the severity of the impact, since it shows the cabin top ripped apart. Encroachment of the fuselage, fire wall, and instrument panel section of the airplane into the cabin area and the reduced volume of the cabin due to folding of the structure is shown in figure 18(c), which is a view of the port side of the airplane. The off-axis impact is again apparent, as shown by the photograph in figure 18(d). The bottom leading edge of the door is against the impact surface, the door is folded outward, and the copilot and seat are resting in the deformed door. There was considerable loss of cabin volume on the starboard side of the fuselage. The interior view of the copilot's position (fig. 18(e)) shows the massive intrusion of the fuselage, fire wall, and instrument panel into the cabin. All seat legs are separated from the floor, and the floor-attached lap belt caused a severe binding of the dummy's pelvic region against the seat. The

(a) View of front of airplane.

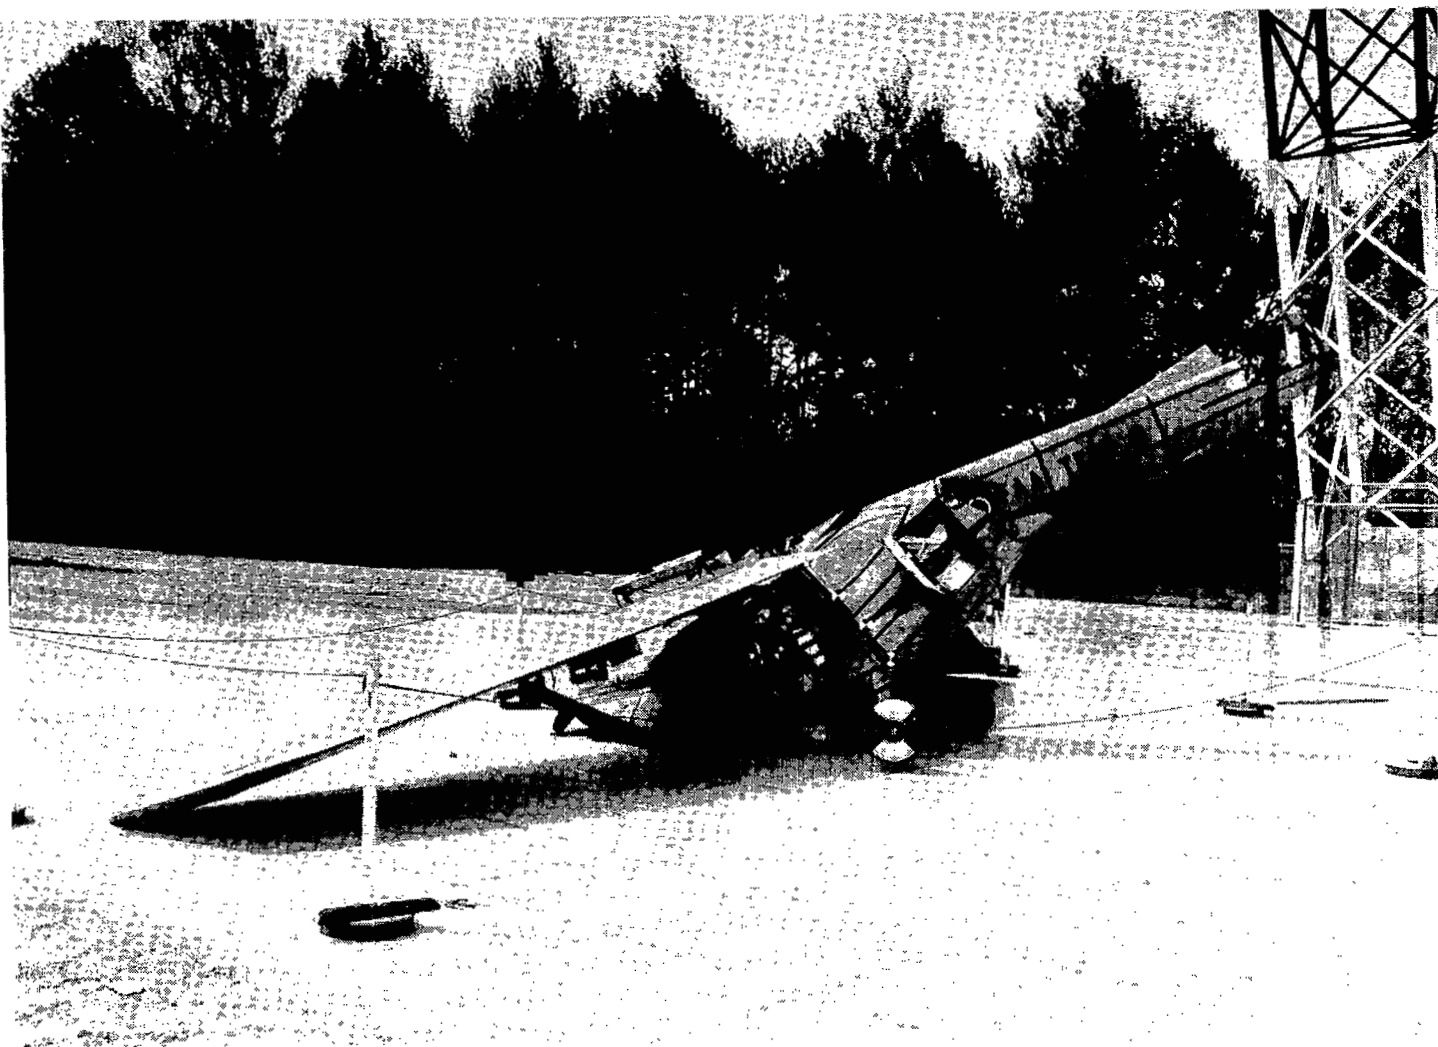
L-77-3211

(c) View of port side of airplane.

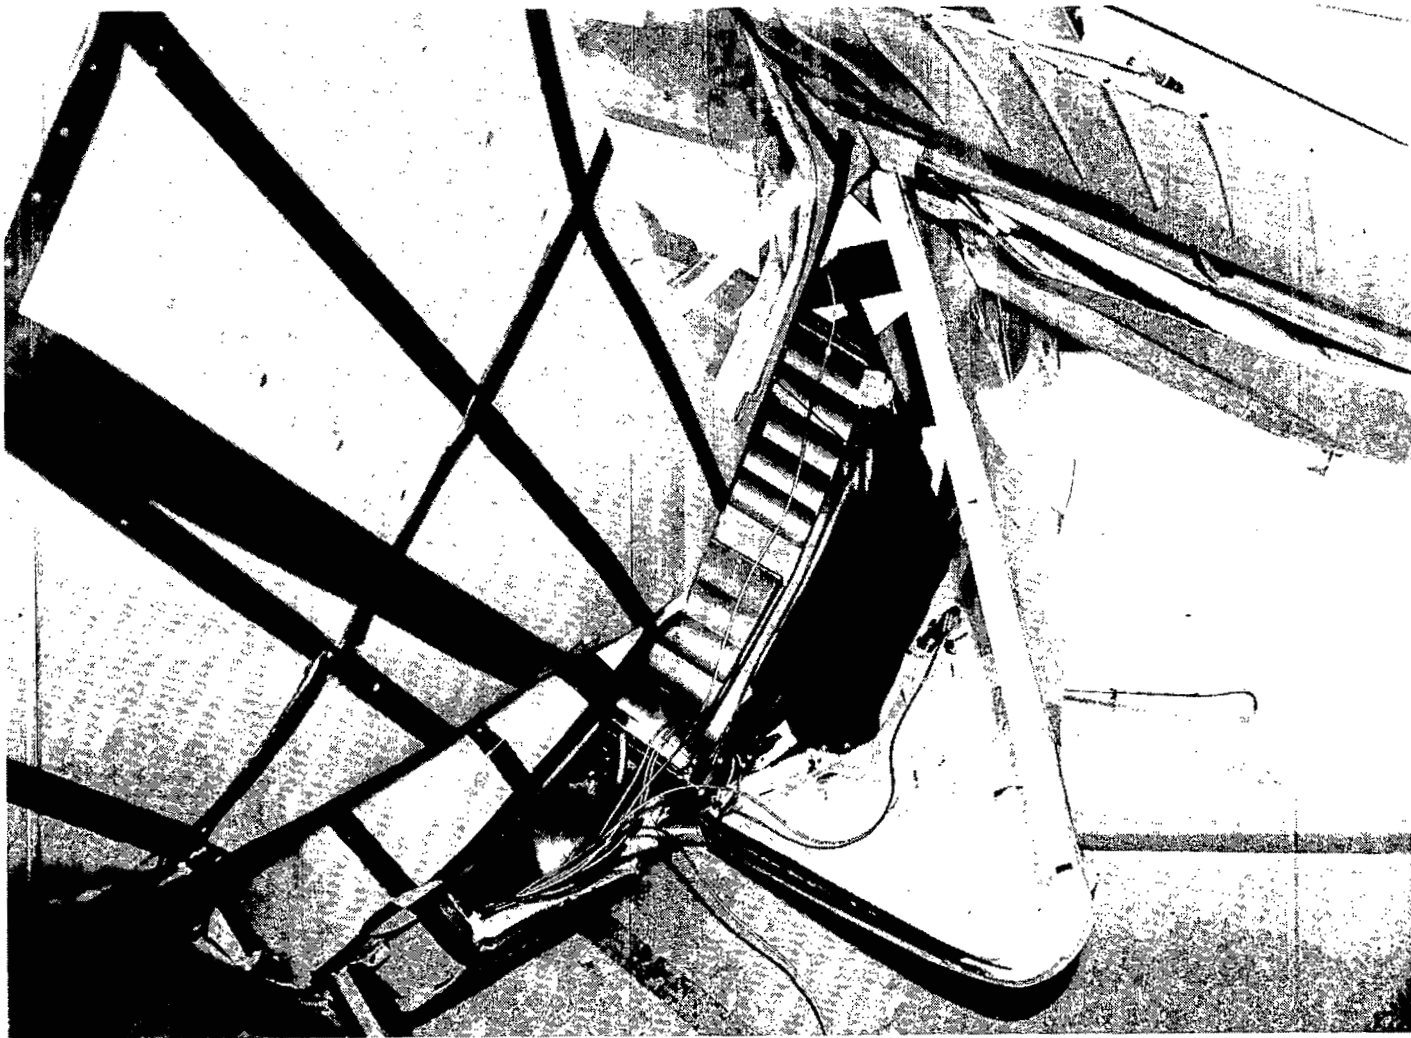
L-77-3199

(d) Close-up view of starboard side door.

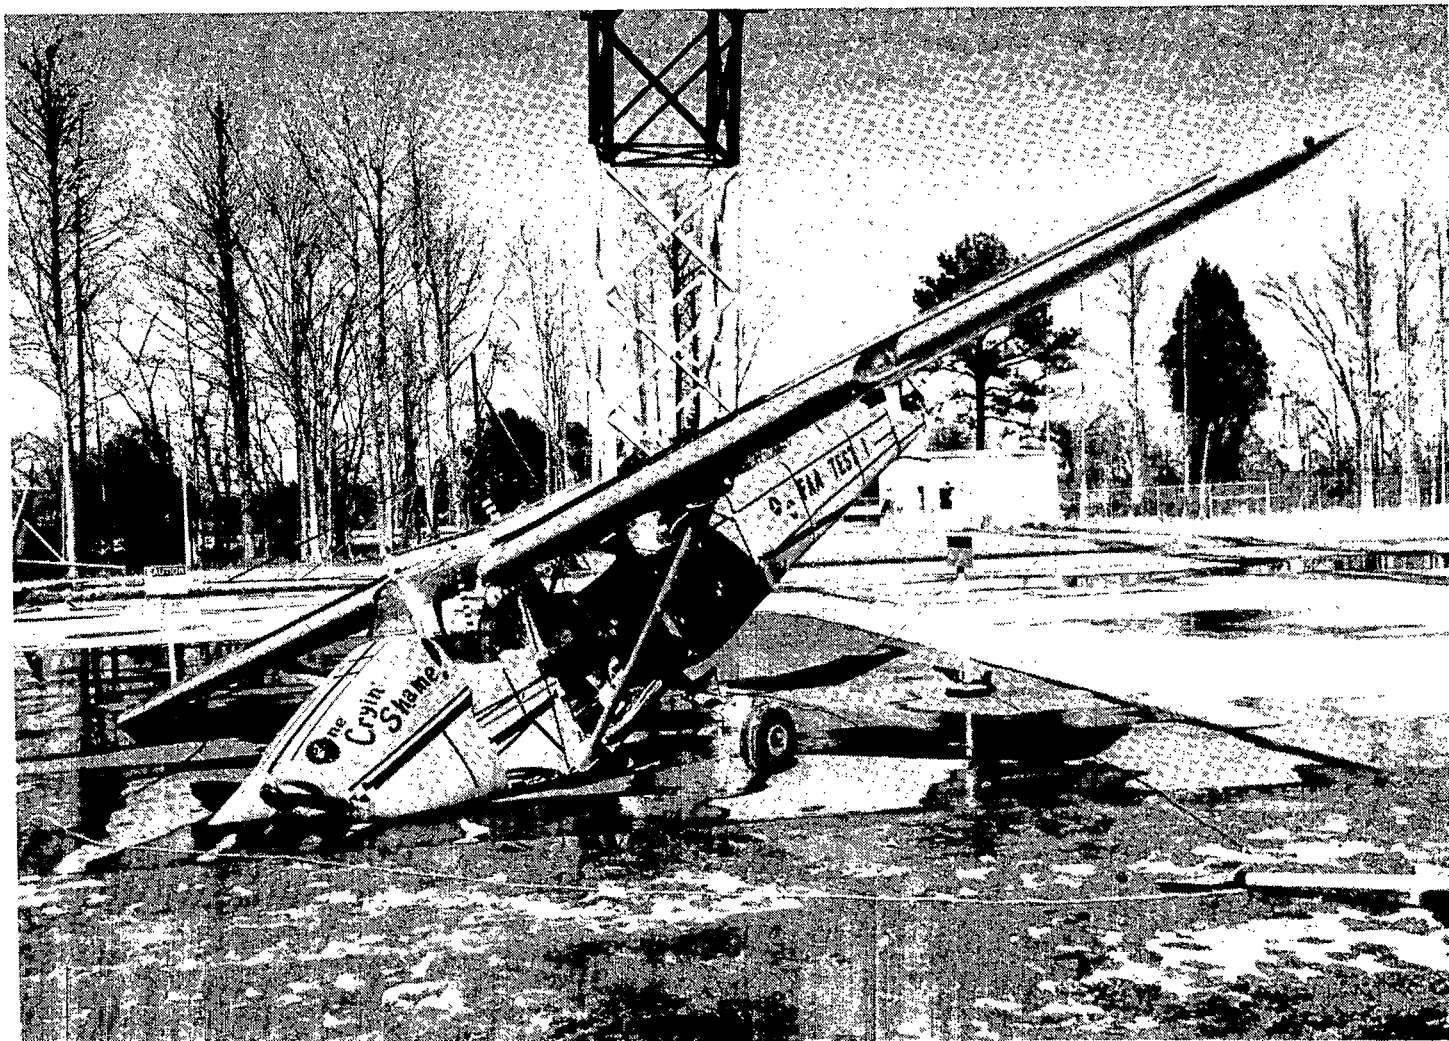
L-77-778

Figure 21(a) shows the final position of the airplane and the overall structural damage. The slope of the lower section of the engine cowling is approximately the angle at which the airplane impacted the concrete. The major cabin damage was in the lower structure at the main landing-gear attachment, as shown in figure 21(b) and the close-up view in figure 21(c). This fuselage-buckling damage resulted from the combination of main landing-gear impact at a  $30^{\circ}$  angle and the downward inertia of the aft end of the fuselage. The interior damage occurred in the area of the passenger compartment with upheaval of the floor, as apparent in figure 21(d). The floor-mounted lap belt was very tight across the pelvic region of the dummy. The rear seat legs had separated from the rail, and the front legs were broken. These circumstances allowed the dummies to be thrown forward but not far enough to contact the instrument panel.

(a) View of front and port side of airplane.

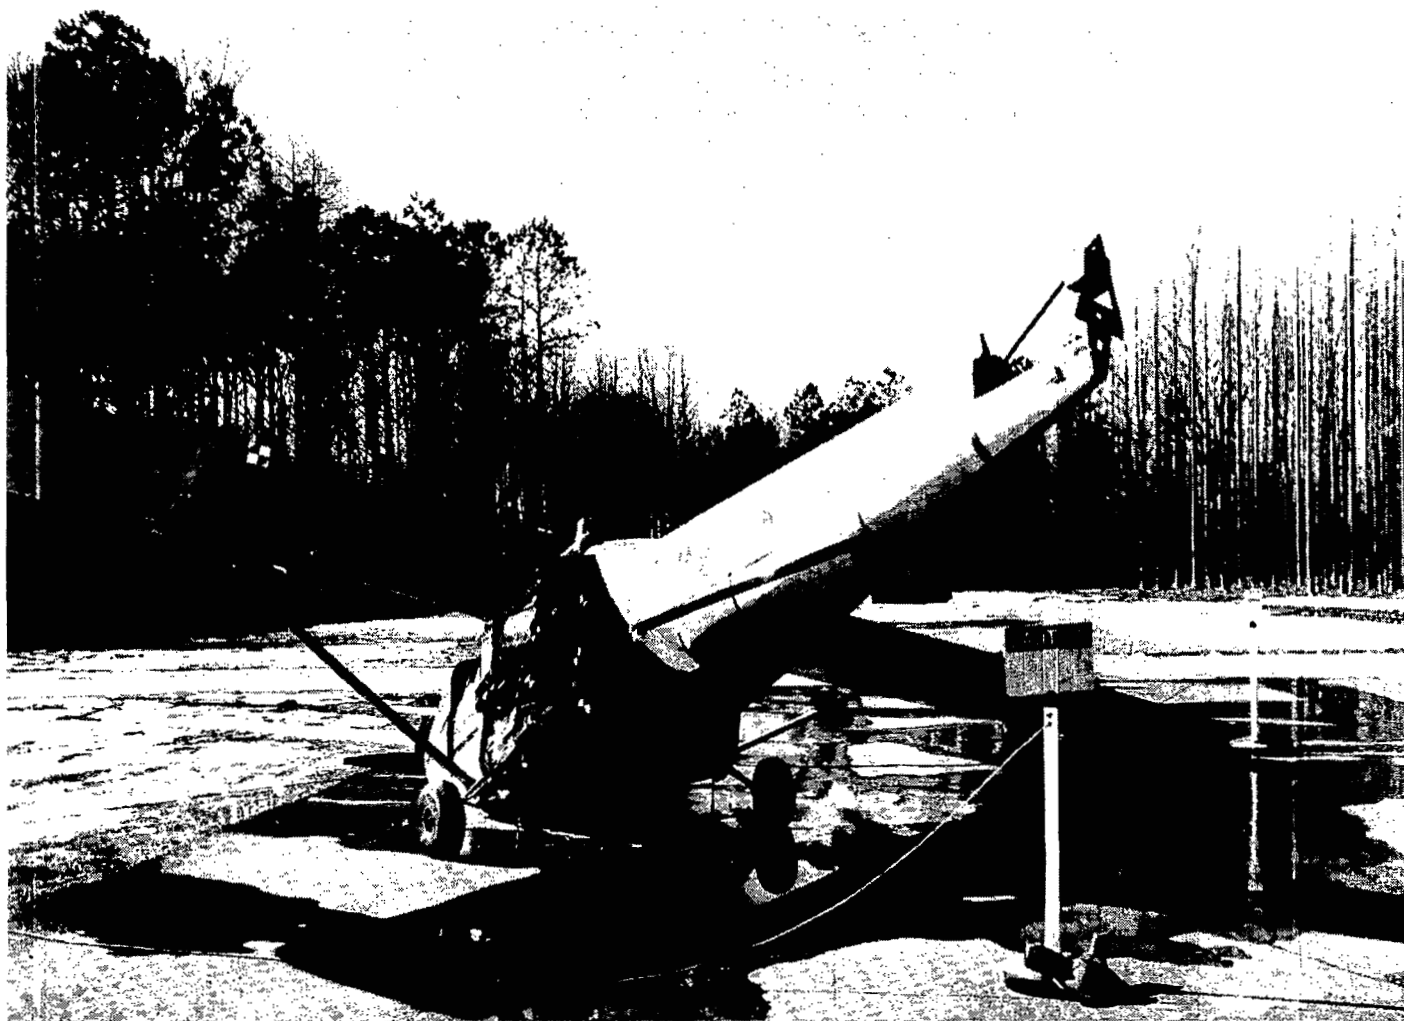
L-77-777

(b) View of aft section of airplane.

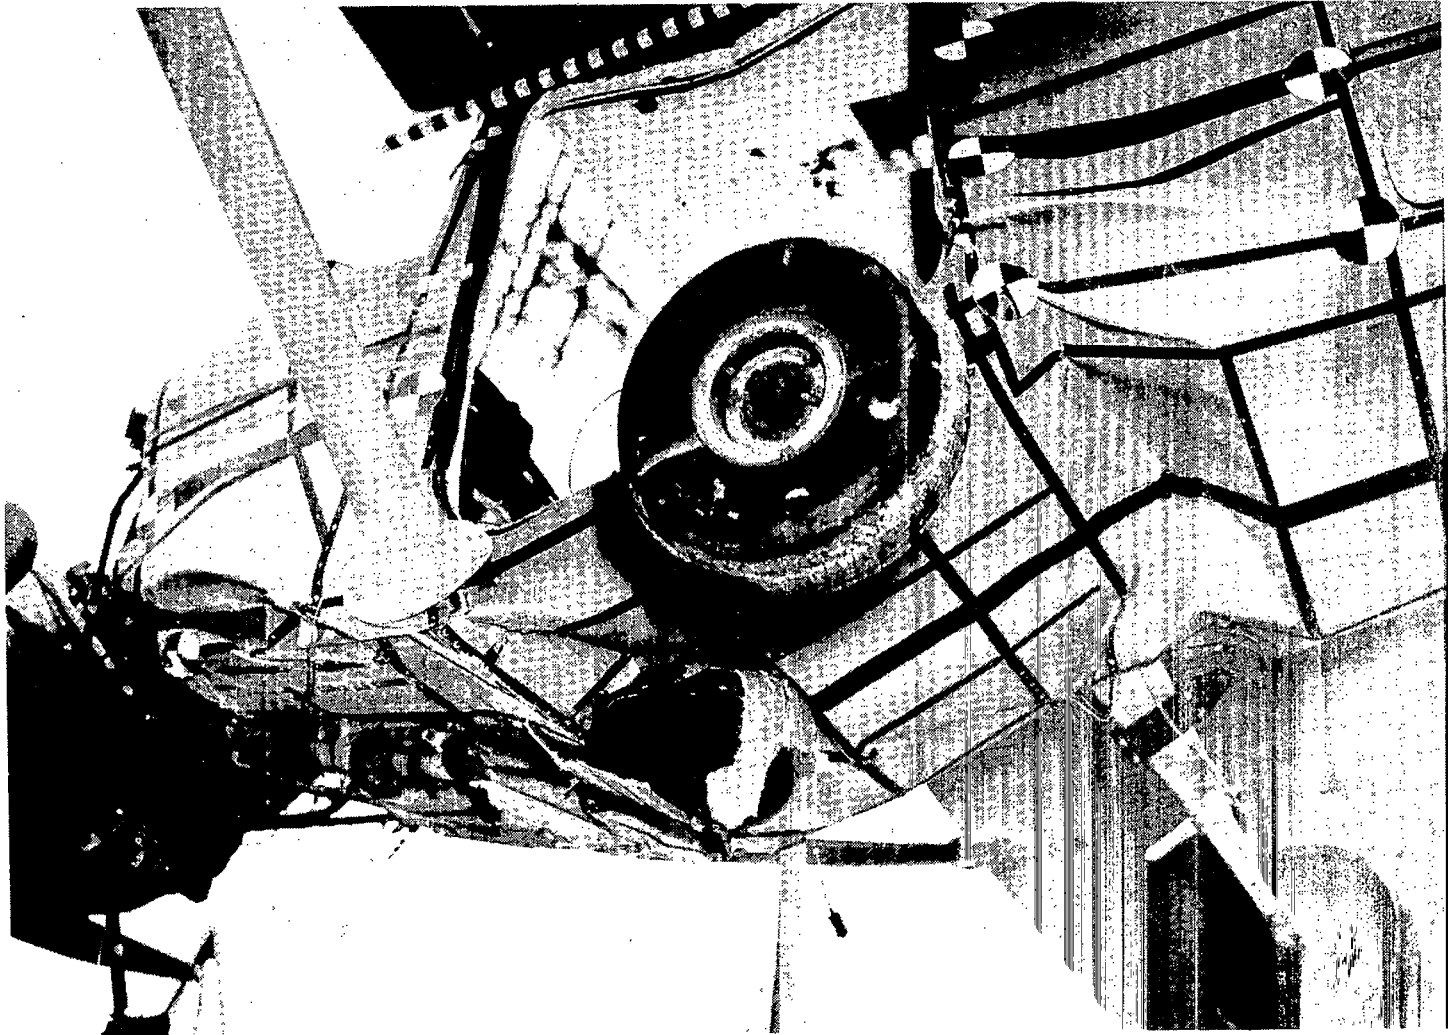
L-77-856

(c) View of bottom of airplane fuselage.

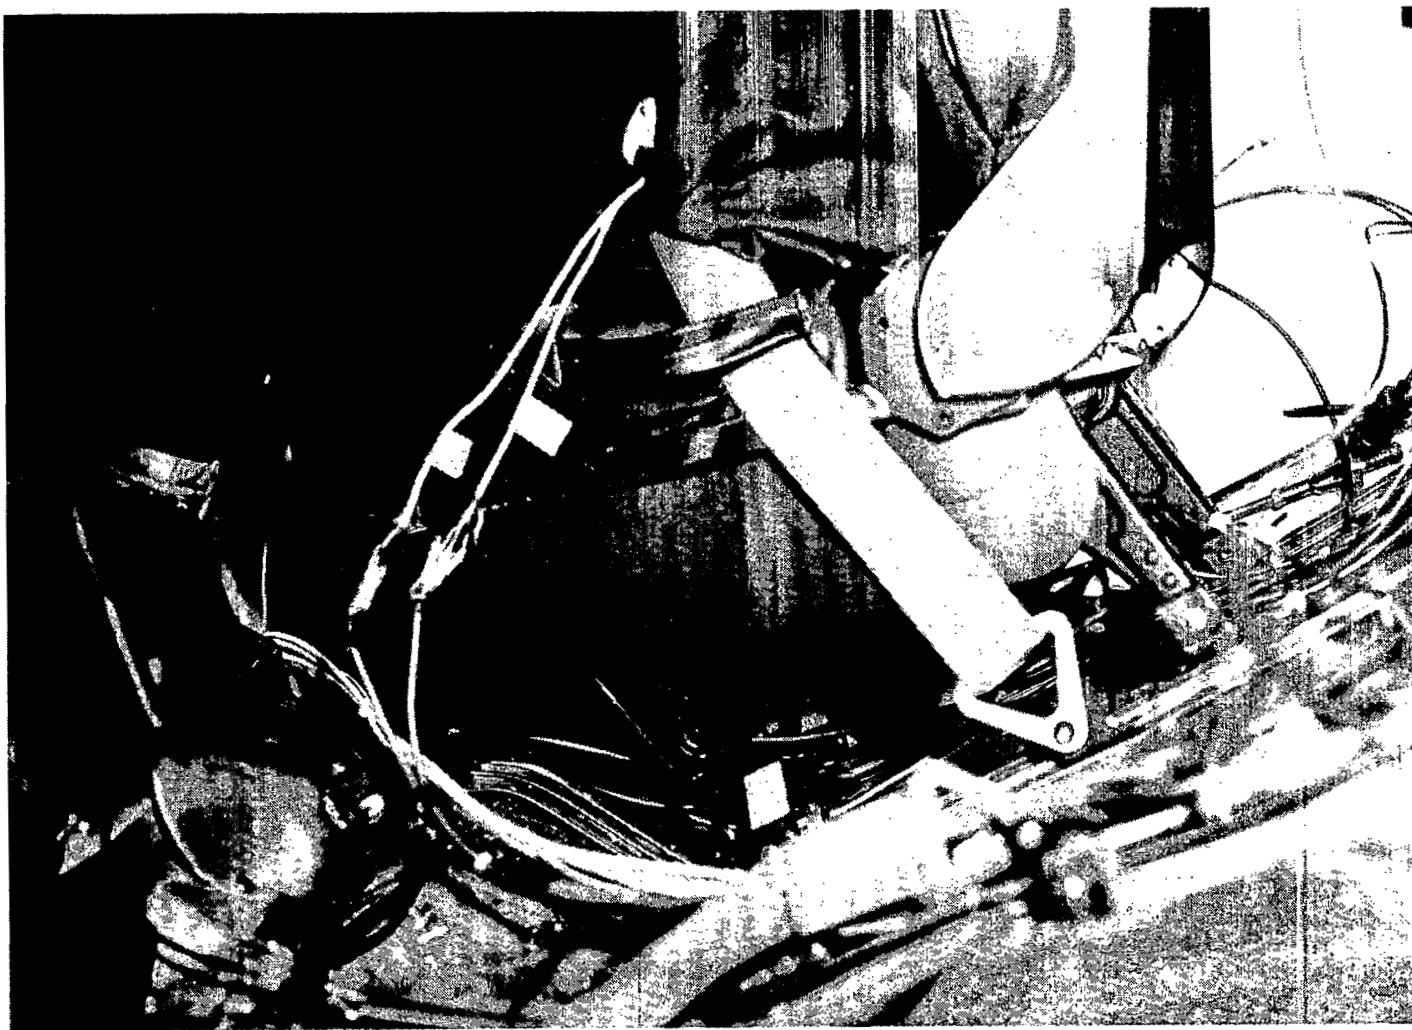
L-77-873

(d) View of copilot's seat and interior of airplane.

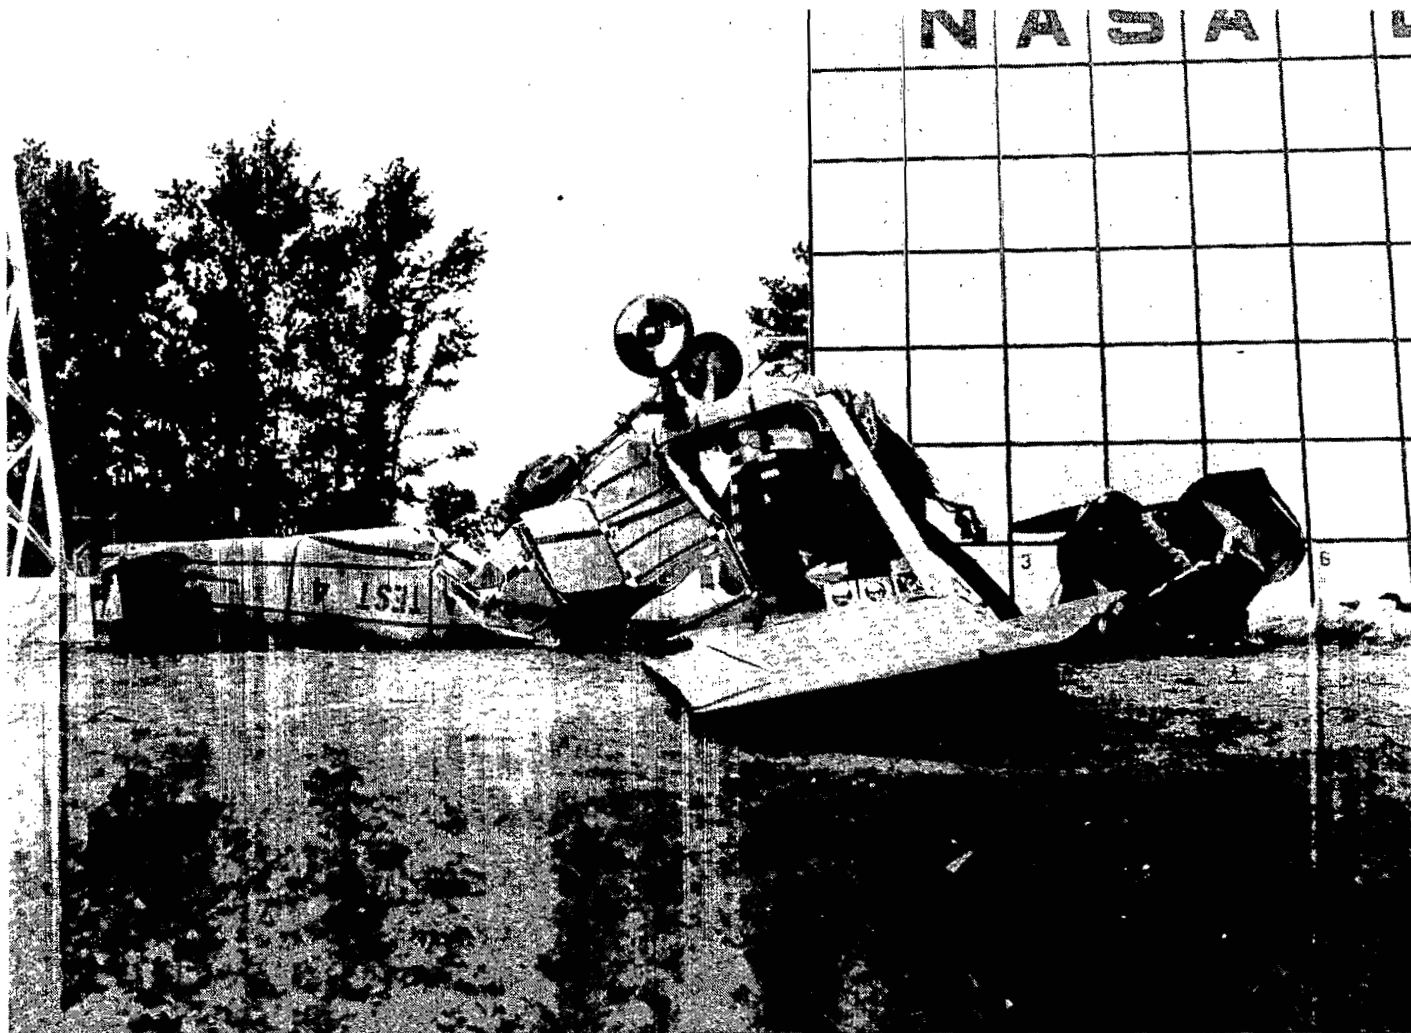
L-77-4342

Figures 24(a) and 24(b) show the final attitude of the airplane and the overall structural damage. The entire fire wall, engine mount, and fuselage structure in front of the pilot and copilot is collapsed to within a few centimeters of the airplane seats. The aft fuselage section is broken just aft of the luggage compartment. The engine is completely separated from the fuselage. Figure 24(c) is a close-up view of the forward section of the fuselage showing that the fire wall has moved back to form a plane between the leading edge of the wing and the fuselage-wing strut junction. The copilot's foot can be seen protruding through the fire wall. There is nothing left of the fuselage

(a) View of port side of airplane.

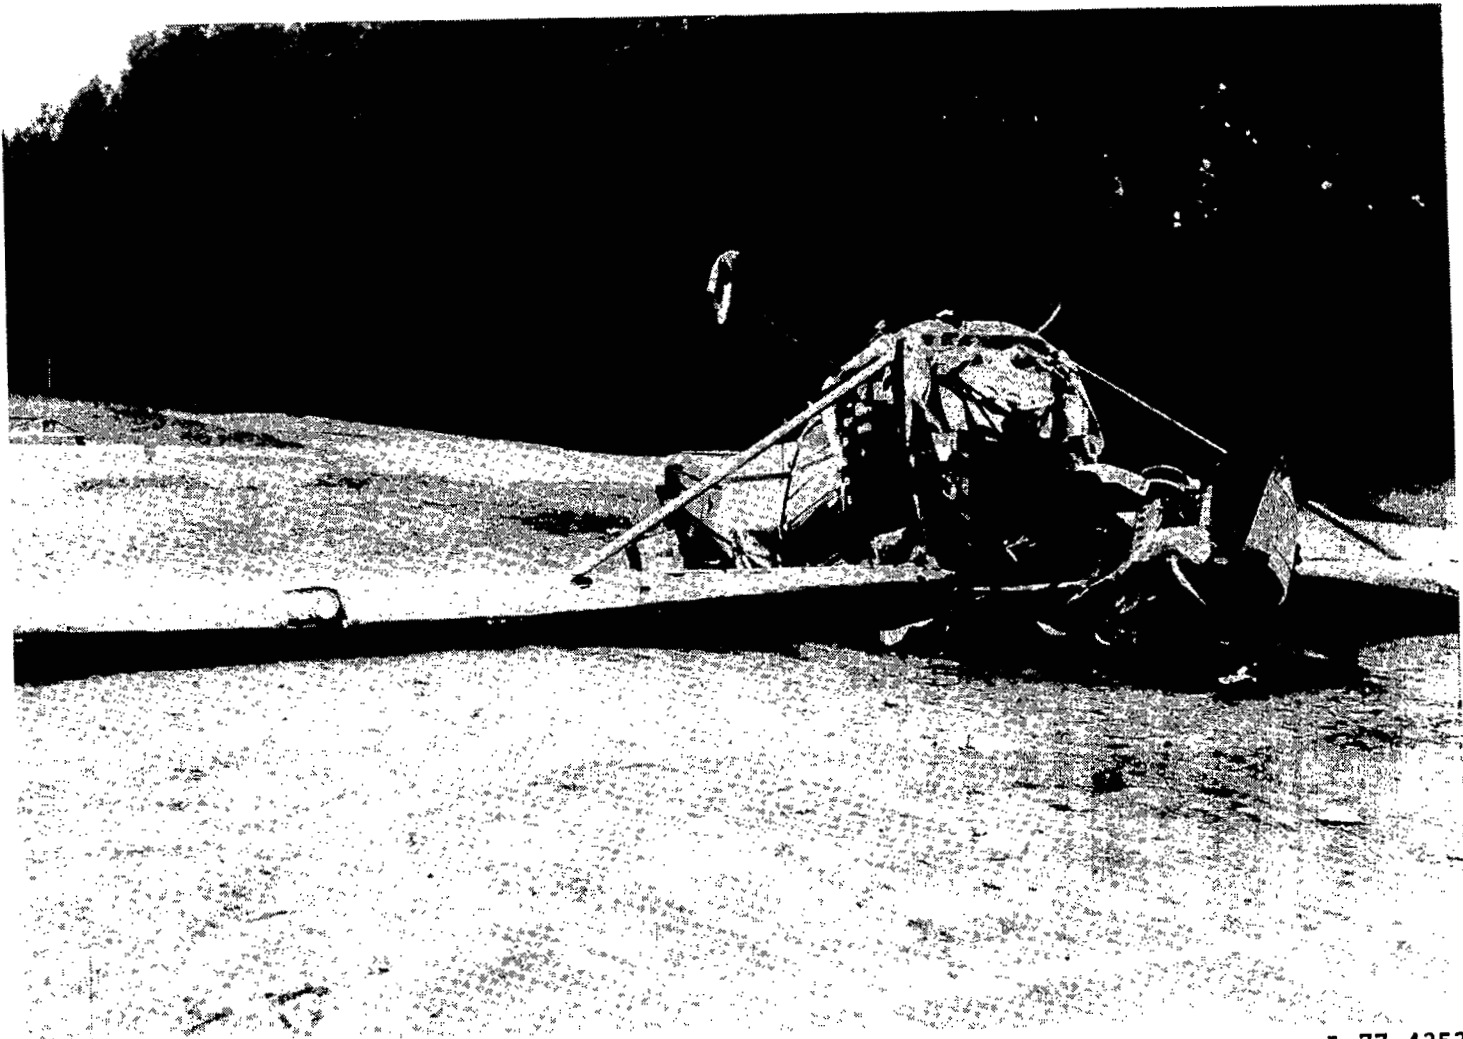
L-77-4353

(b) View of front of airplane.

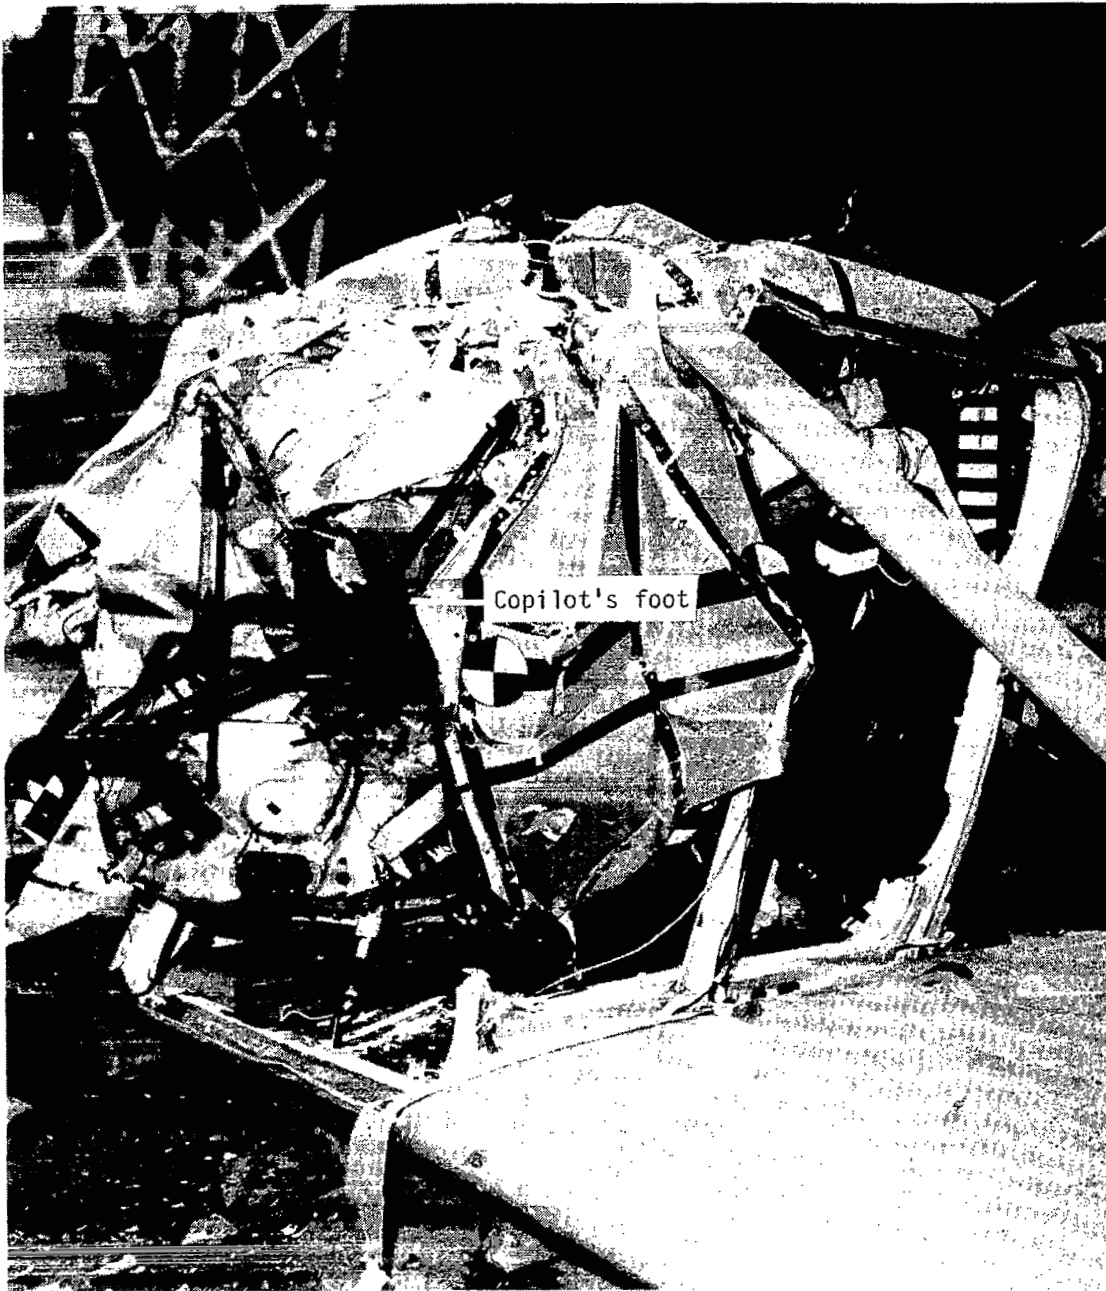
L-77-4352.1

(c) Close-up view of front of fuselage and fire wall.

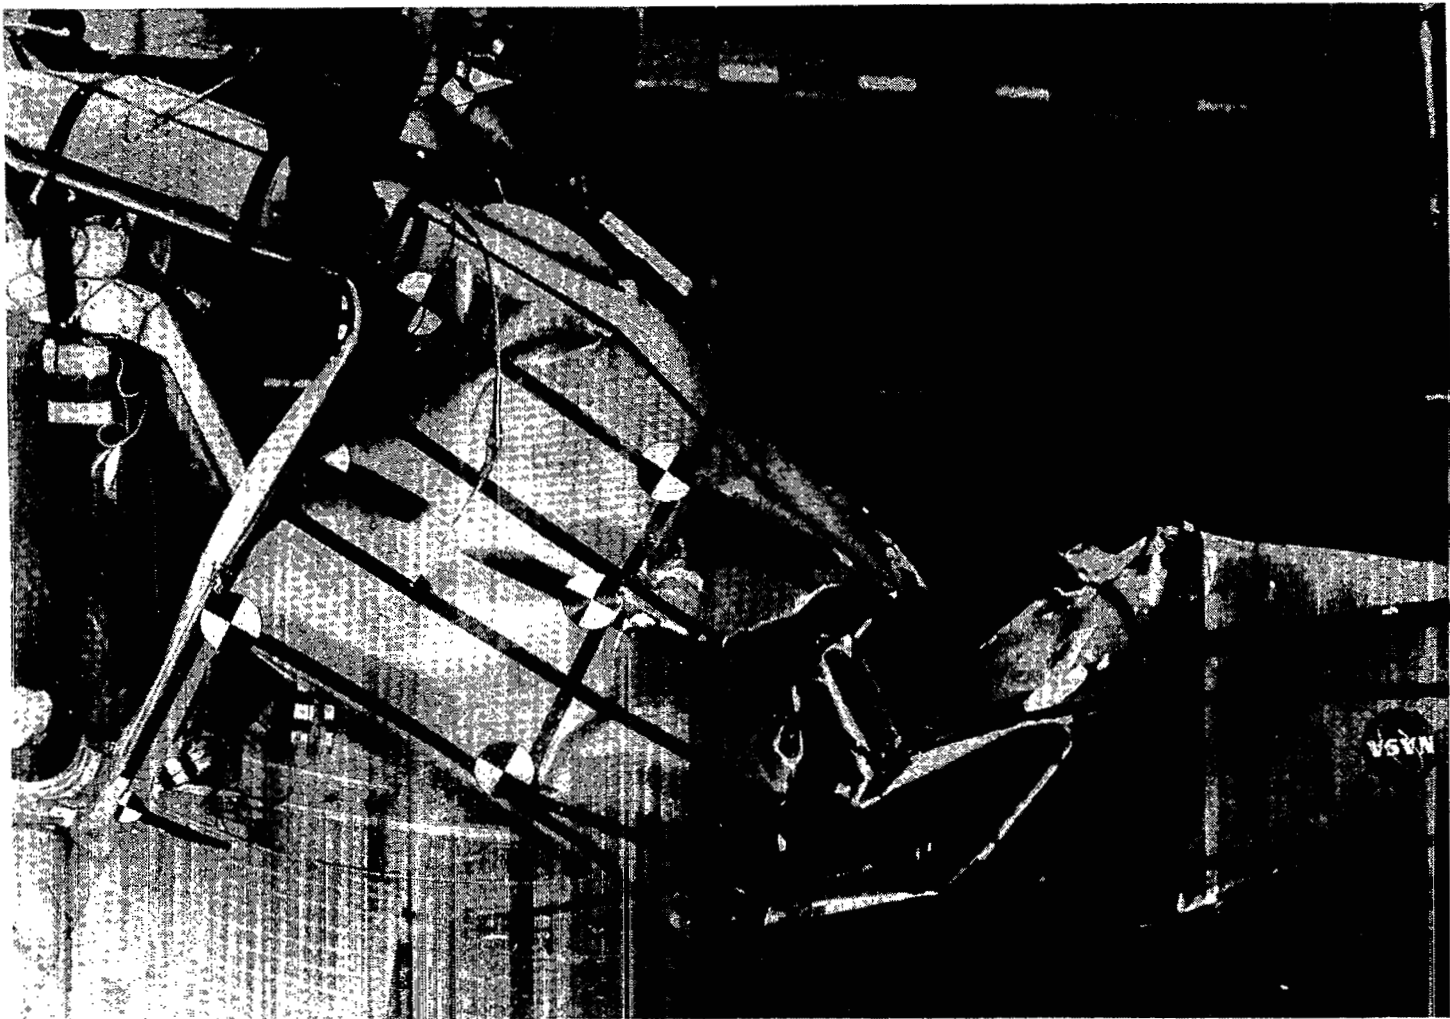
L-77-4369

forward of the leading edge of the wing. The aft section of the fuselage is shown in a close-up view in figure 24(d). The fuselage is broken at the luggage compartment rear bulkhead, and the luggage compartment volume has been greatly reduced. The final position of the pilot within the damaged airplane is shown in figure 24(e). The fuselage floor is displaced upward, pressing the dummy's head against the upper cabin with the shoulder level at the top of the door opening. The fire wall, fuselage forward floor, and instrument panel pushed the dummy's legs back to the front of the seat. The lap belt is attached to the floor and is tight around the dummy's pelvis. Figure 24(f) shows the pilot's station after the dummy had been removed. It is apparent that all structure in front of the pilot has been completely demolished. In addition, the pilot clearly contacted this structure head on during the impact. Figure 24(g) shows that the copilot's position was about the same as the pilot's; however, the forward fuselage structure shows more penetration into the cabin area on the copilot's side than on the pilot's side. The copilot dummy had both legs broken just below the knee as a result of the structural impact against the legs.

(d) Close-up view of aft section of airplane.

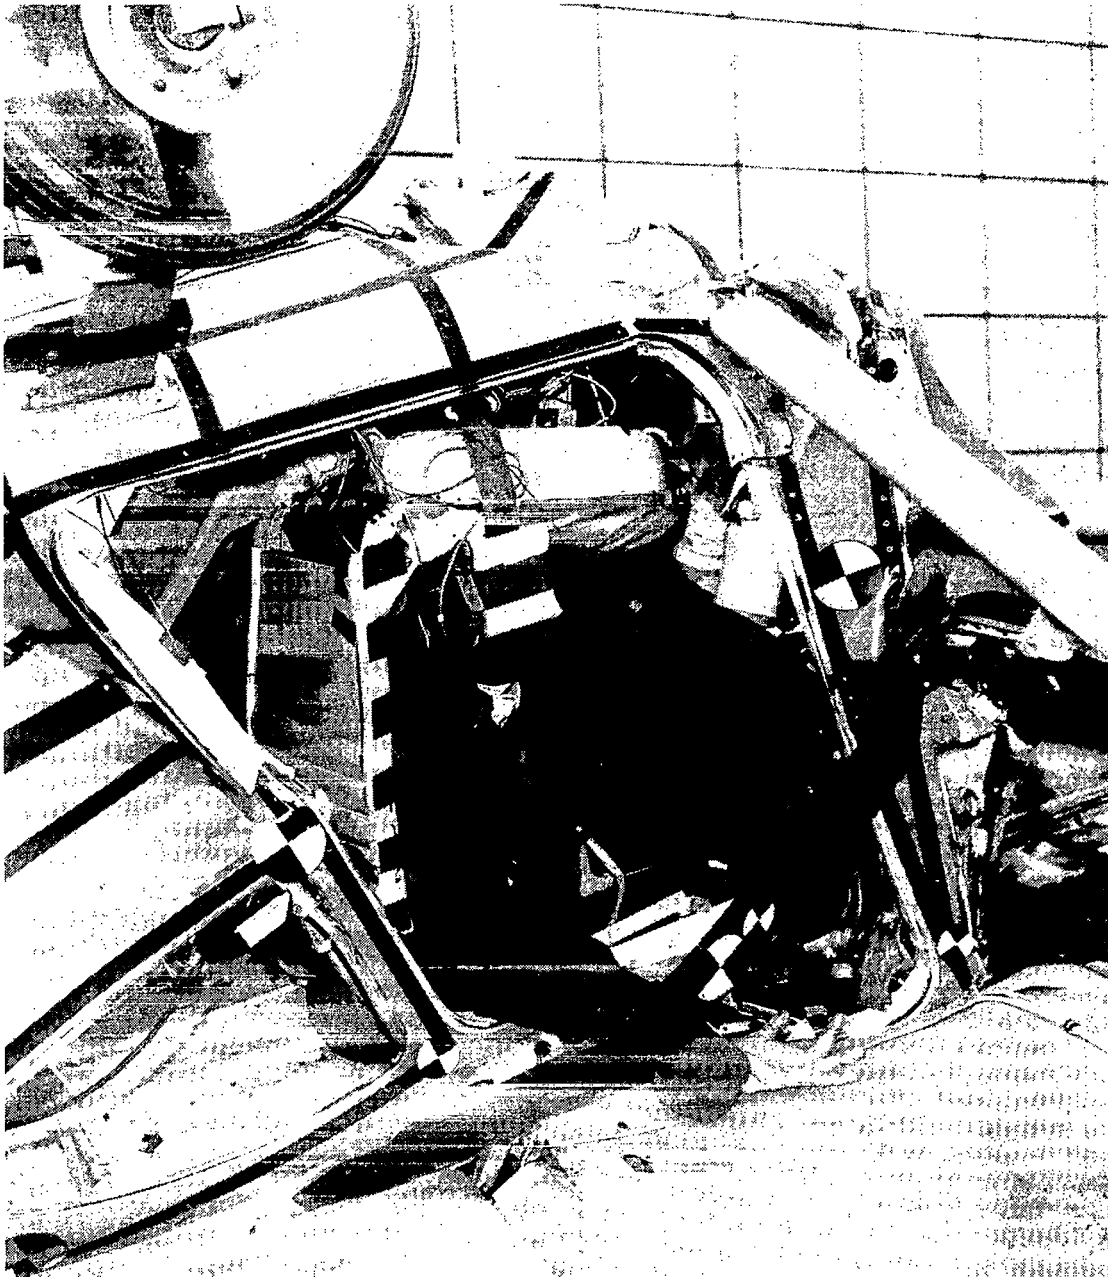
L-77-4354

(e) Close-up view of pilot's position in crashed airplane.
